# **Washington Department of Ecology Everett Smelter Site Summer 1999 Cleanup**

## **Details of Cleanup Activities**

Property Owners: Dave and Jeanne Taylor

Address:  
538/556 East Marine View Drive  
Everett, WA 98201

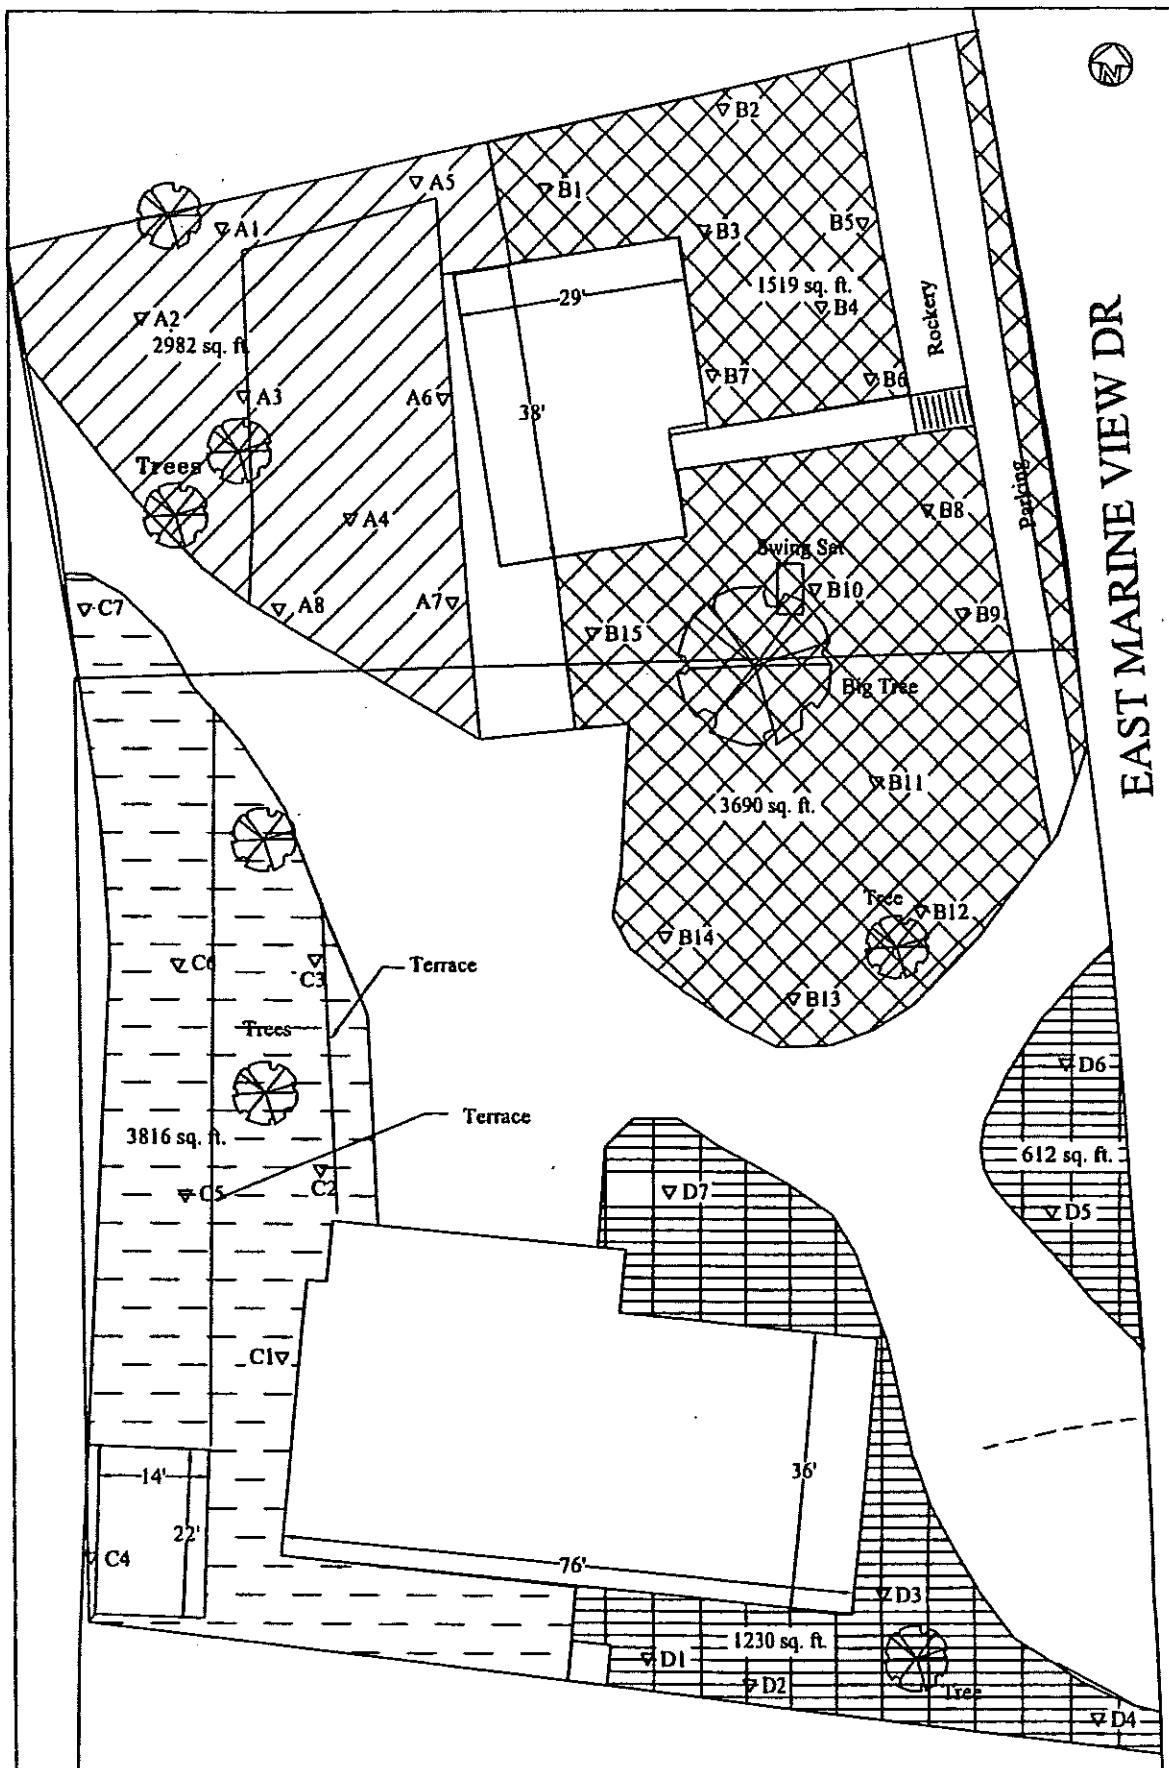
538 EAST MARINE VIEW DRIVE

This property was divided by Ecology into four Decision Units, A, B, C, and D, as shown on the attached map, for purposes of pre-cleanup sampling and decision-making regarding the depth to which excavation was required. The following is a summary of the work done in the remediation of the property within each of the decision units.
